**Preliminary Characterization
of the Hydrology and Water Chemistry
of the Sunnyside Mine and Vicinity,
San Juan County, Colorado**

February 11, 1992

San Juan County Mining Venture
Washington Mining Company - Operator
P.O. Box 177
Silverton, Colorado 81433

Simon Hydro-Search
5250 South Virginia, Suite 280
Reno, Nevada 89502

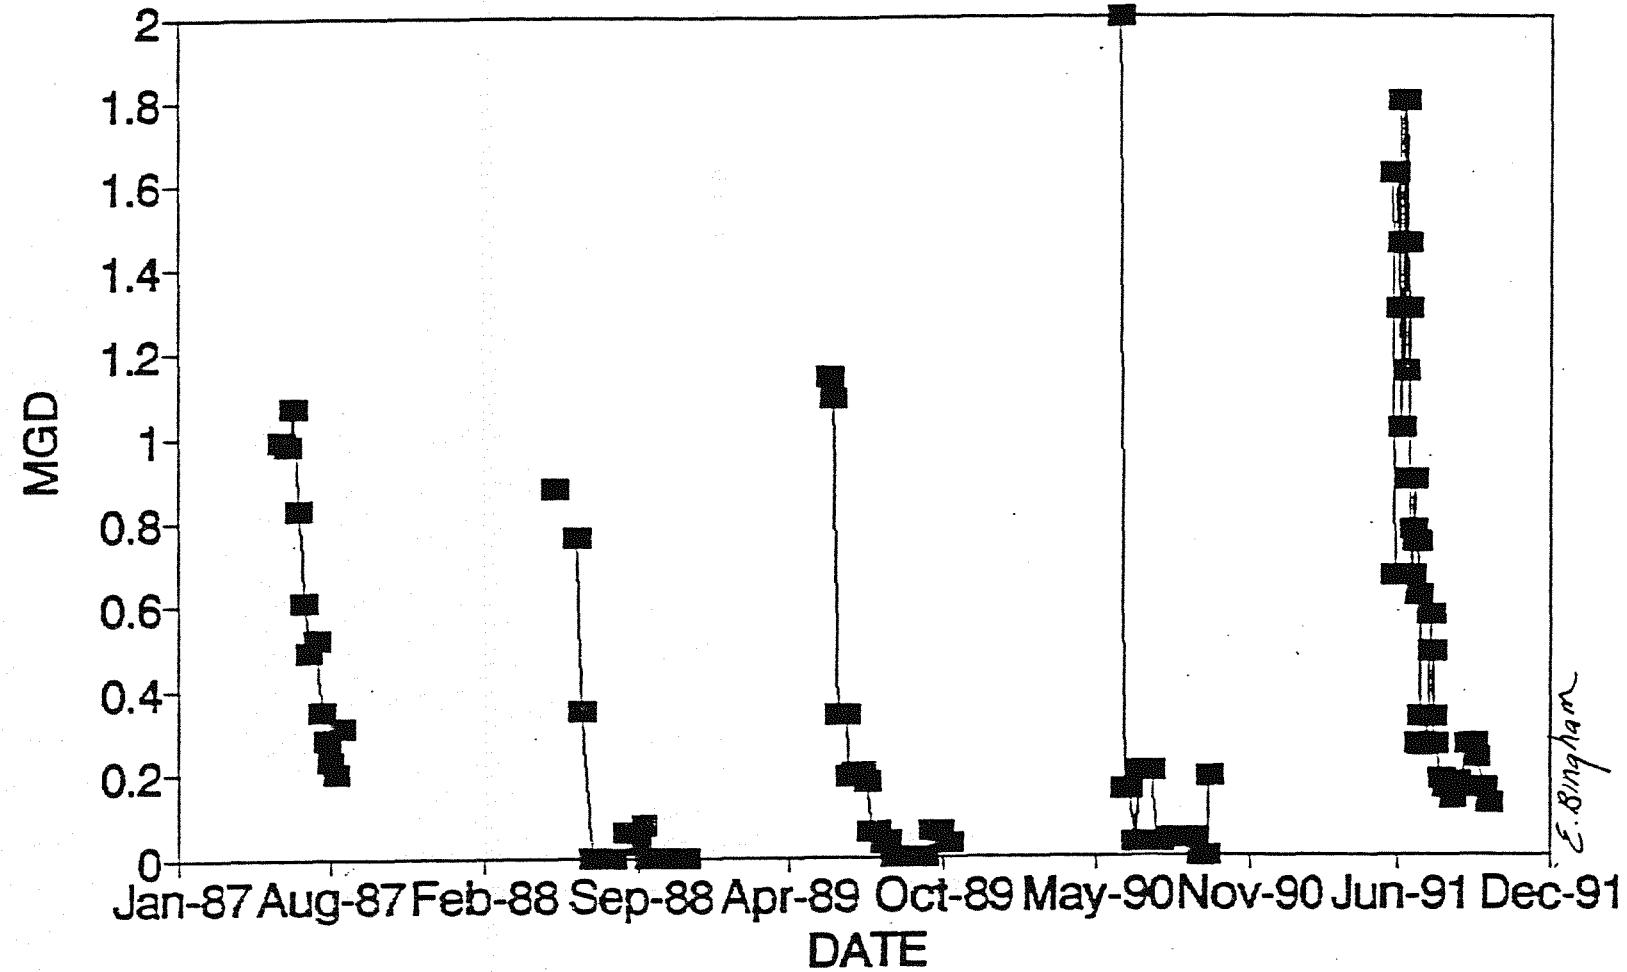
Hydro-Search, Inc. HYDROLOGISTS-GEOLOGISTS-ENGINEERS	Figure 7

Figures 7 and 8 illustrate the present seasonal variation in flow from the Terry Tunnel. Flow from the Terry Tunnel is measured with an "H" flume below the settling ponds. Flow measurements from 1988 through fall of 1990 may be somewhat underestimated due to pond leakage (which is now insignificant) and inadequate leveling of the flume. No measurements are taken during winter and spring because the access road to the Terry Tunnel is typically impassible until late May. Figure 7 shows a peak flow in early June, but it is possible that the peak flow may have occurred prior to the first gauging in some prior years.

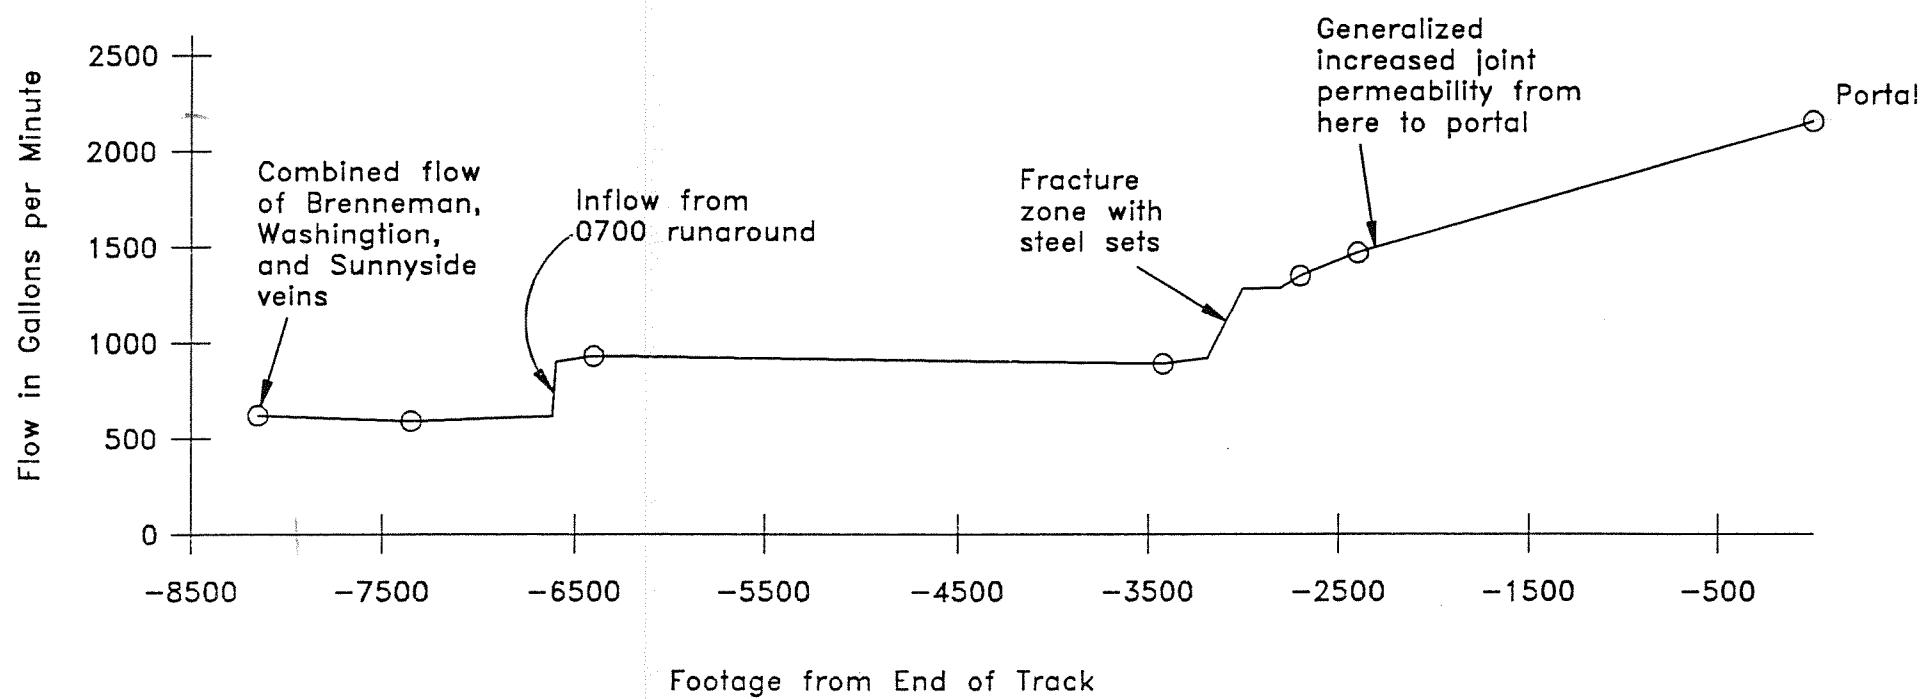
In the deeper parts of the American Tunnel (farther than approximately 2500 feet from the portal) the majority of water transmitted to the tunnel originates from a few fracture zones (Figure 10). Major permeable zones include the Washington vein (190 gpm), the Brenneman vein (200 gpm) the Sunnyside vein (180 gpm), a fracture zone at the 0700 runaround (approximately 340 gpm), and a fracture zone located 3020 to 3220 feet from the outside end of the track (approximately 400 gpm).

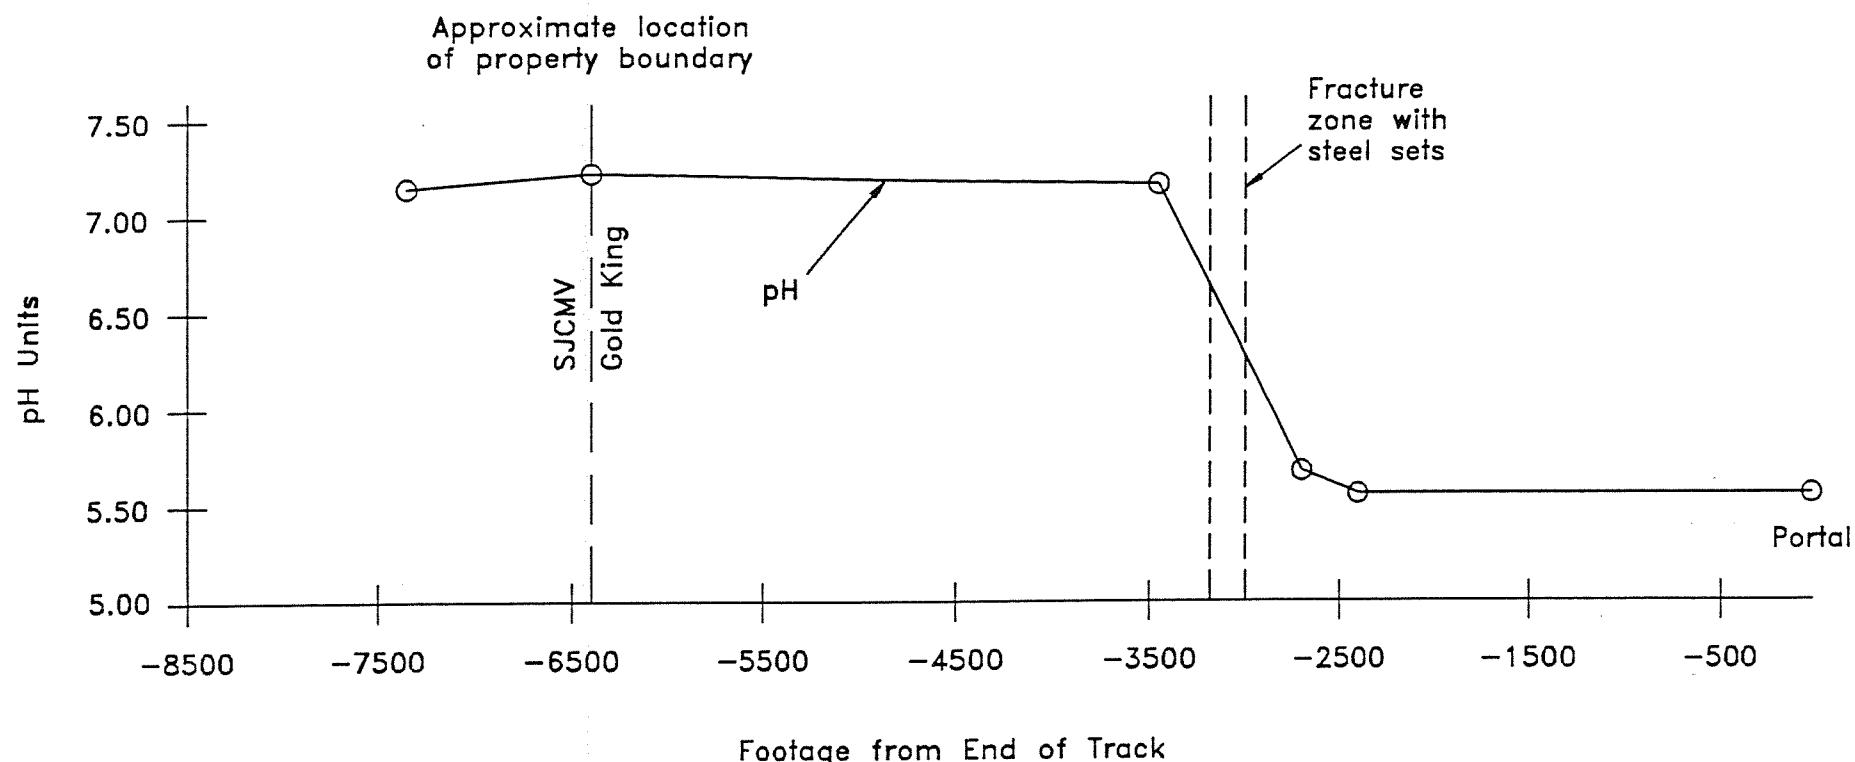
The majority of the total metals load and the acid entering the American Tunnel originates downstream of the SJCMV property line. Figures 11, 12, and 13 are profiles of water chemistry along the American Tunnel. Figure 11 shows that on October 2 and 3, 1991 the flow in the American Tunnel had a nearly neutral pH until it encountered water entering from the fracture zone at the "steel sets" between 3020 and 3220 feet from the end of the track. Water from the steel sets fracture zone was sufficiently acidic to reduce the pH of the overall flow to approximately 5.5.

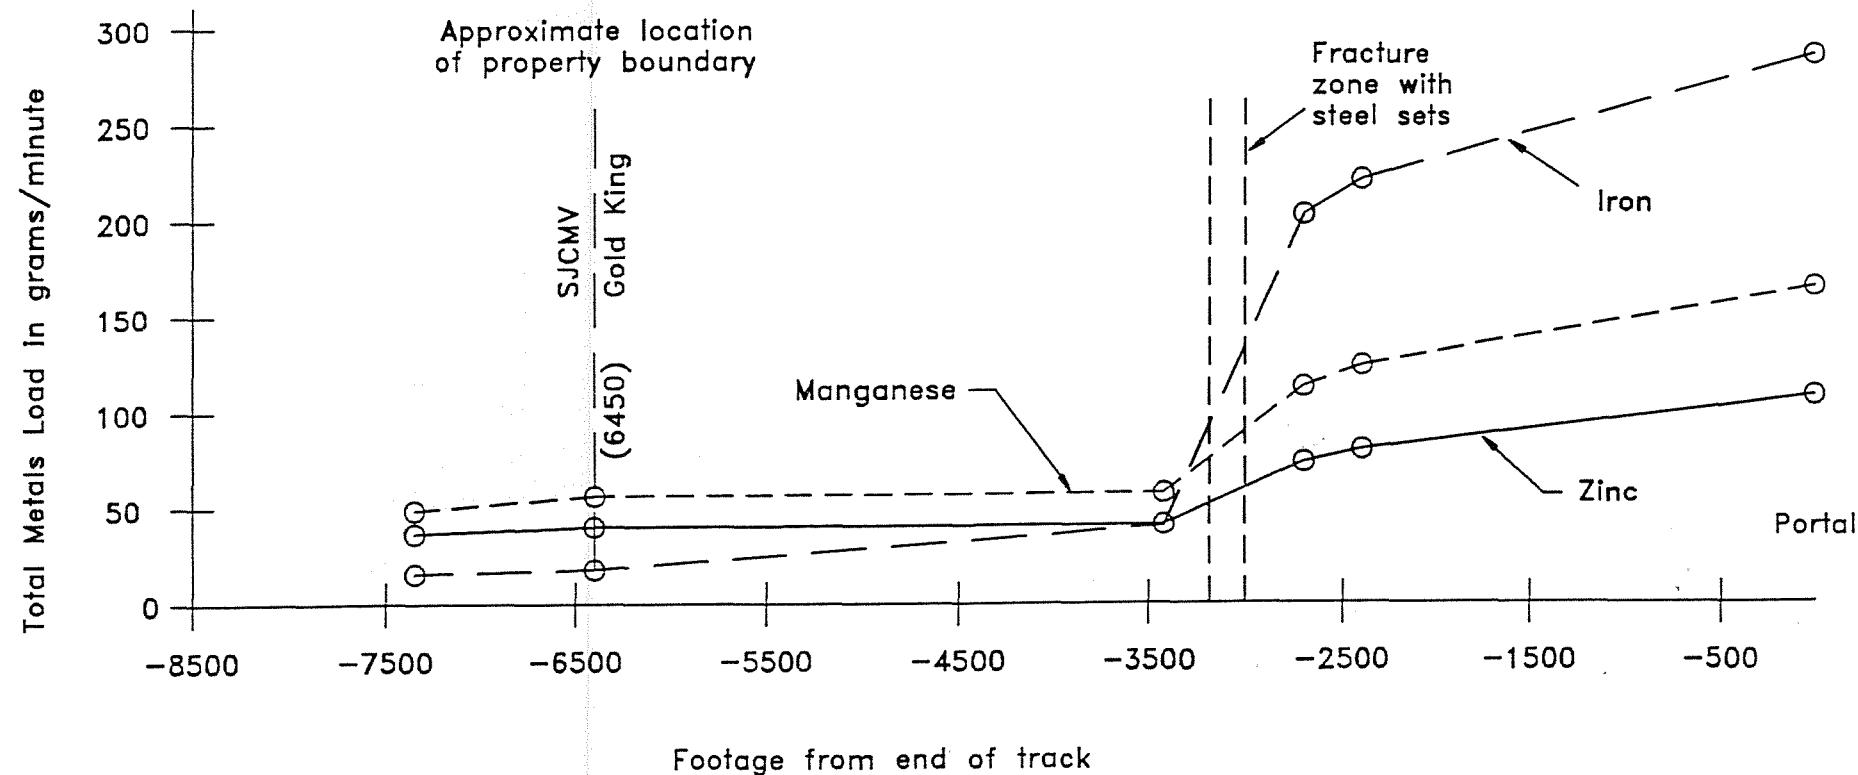
San Juan County Mining Venture Silverton, Colorado	DATE: 01/21/92
	DRAWN: KEK
	CHECKED: MJS
	APPROVED: J. Fox
	DWG NO:
	PROJ.: 464110361
Load of Mn, Fe, and Zn Carried in American Tunnel Ditch	
HSI Hydro-Search, Inc. HYDROLOGISTS-GEOLOGISTS-ENGINEERS	Figure 12

The total load of metals carried by a stream is the flow rate times the total metals concentrations. Figure 12 shows that the total metals load of iron, zinc, and manganese in American Tunnel ditch water dramatically increases after the steel sets fracture zone. The load of iron, zinc, and manganese continues to increase at a lesser rate throughout the last 2500 feet of the American Tunnel where dripping water enters the tunnel from relatively minor joints.

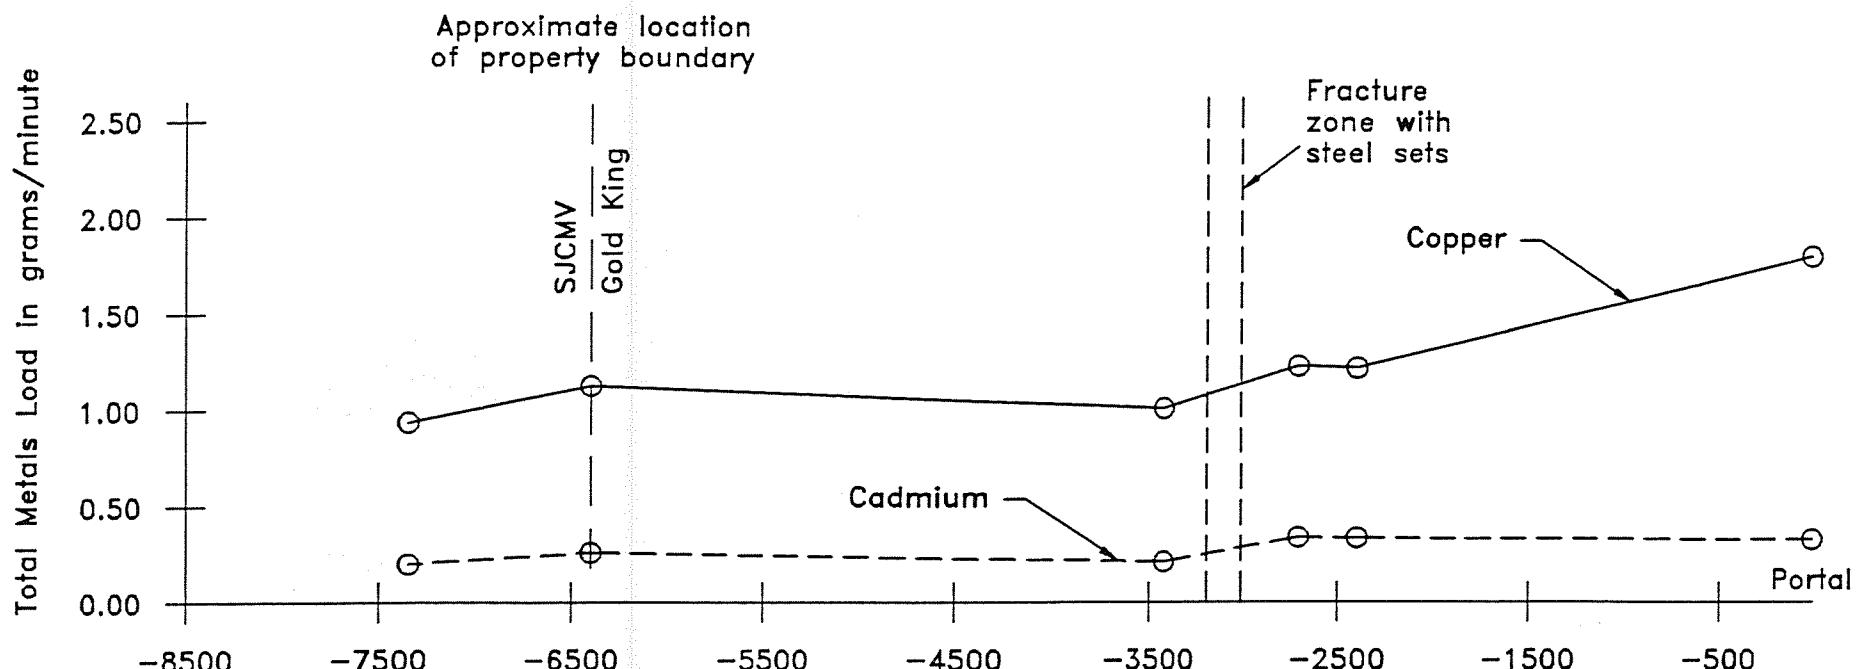
Figure 13 shows that the total metals load of copper and cadmium in American Tunnel ditch water also increases at the steel sets fracture zone. The load of cadmium does not increase downstream of this point, but the load of copper continues to increase in the last 2500 feet of the tunnel.
